OREGON FATALITY ASSESSMENT AND CONTROL EVALUATION

Fatality Investigation Report

OR 2004-10-1

Forklift crushes operator working underneath on starter

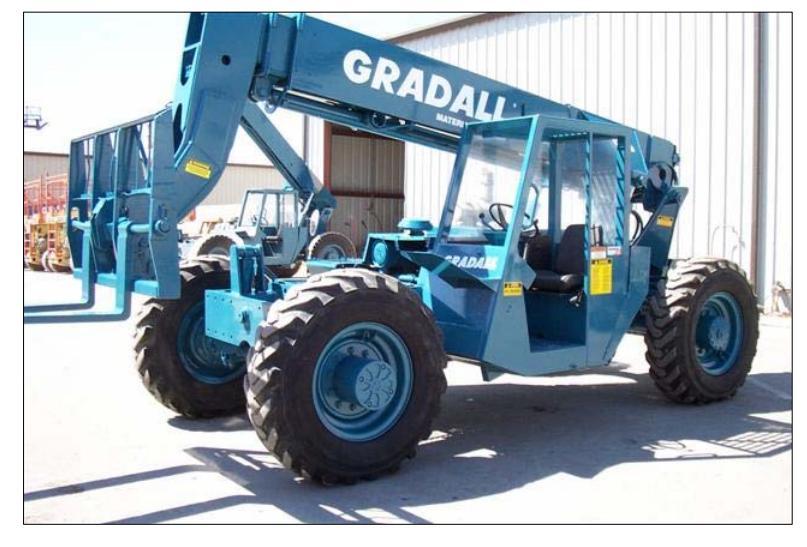
On June 4, 2004, a 47-year-old co-owner of a recycling business was run over and killed by a Gradall telescopic boom lift (rough-terrain forklift) while he was working underneath it. He had been operating the Gradall, and had shut it down when he momentarily exited the vehicle. When he returned to the machine, he found it would not restart. The Gradall had a safety interlock that prevented starting from the

ignition switch while in gear. The contractor was apparently unaware of this safety feature. He checked the batteries, and then crawled underneath the cab area and reached up into the engine compartment with a screwdriver. The screwdriver made contact between the two terminals on the starter, effectively jump-starting the engine and bypassing the safety mechanism that prevented ignition while in gear. The Gradall started and moved forward. The parking brake was not set. The back left tire rolled over the contractor.

- Powered industrial forklifts should only be operated by knowledgeable and experienced individuals certified by the employer, with proficiency demonstrated through operator training.
- Before exiting any powered industrial truck, even briefly, completely shut down power, place controls in neutral and apply parking brake.
- Do not start equipment by overriding safety features.
